Darrington Collaborative
FS 2060 - CLEAR CREEK ROAD
T 31 N - R 10 E
Snohomish County
2016

Draft 6-17-13

Clear Creek Riparian Restoration Project: Forest Service Roads #2060 & 2065

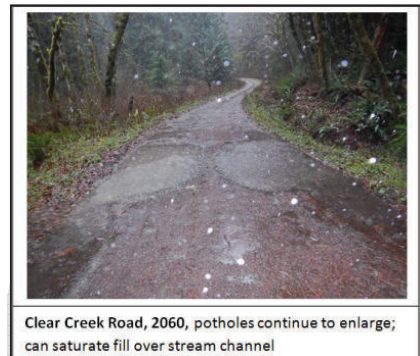
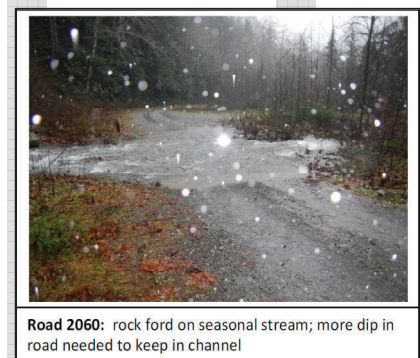
Current Road Conditions: The 2060 & 2065 roads are heavily used for recreational access. Large pot holes have developed in the lower (northern portion) of the road. Material continues to be eroded by vehicle traffic. Road ditches have filled in many places, lost capacity and now allow water to flow over the road and erode the surfacing. Road surface has scour channels in numerous places. Ditch drainage flows directly into creeks in numerous places. Impeded road drainage makes road surfacing & sub-grade more likely to saturate and possibly fail. It weakens the road and increases erosion from vehicle traffic. Natural debris flows from Jumbo Mountain periodically divert and flow down portions of road rather than the established channel. Existing road surface aggregate is fine gravel subject to erosion when heavy rain caused surface flows occur or from snow melt.

Project Goals: New large (probably 2.5"), durable, rock surfacing on the road to reduce erosion and to better infiltrate surface runoff. Ditches cleaned where necessary and configured such that road drainage does not flow into creeks. New plastic culverts¹ installed as necessary. Road dipped as necessary in places of historic (periodic) debris flows to reduce likelihood of flows diverting down road. (This helps maintain natural role and place of debris flows in adding complexity to streams from wood and rock inputs) General goal is to bring this National Forest Road up to standards. Overall goal is to minimize potential road system impacts on Clear Creek and restore natural water flows.
